**DEPARTMENT OF TRANSPORTATION****DIVISION OF ENGINEERING SERVICES**

Quality Assurance and Source Inspection

Contract #: 04-0120F4Cty: SF/ALA Rte: 80 PM: 13.2/13.9File #: 1.28**WELDING INSPECTION REPORT****Resident Engineer:** Pursell, Gary**Address:** 333 Burma Road**City:** Oakland, CA 94607**Report No:** WIR-015741**Date Inspected:** 20-Jul-2010**Project Name:** SAS Superstructure**OSM Arrival Time:** 700**Prime Contractor:** American Bridge/Fluor Enterprises, a JV**OSM Departure Time:** 1530**Contractor:** American Bridge/Fluor Enterprises, a JV**Location:** Jobsite**CWI Name:** See below**CWI Present:** Yes No**Inspected CWI report:** Yes No N/A**Rod Oven in Use:** Yes No N/A**Electrode to specification:** Yes No N/A**Weld Procedures Followed:** Yes No N/A**Qualified Welders:** Yes No N/A**Verified Joint Fit-up:** Yes No N/A**Approved Drawings:** Yes No N/A**Approved WPS:** Yes No N/A**Delayed / Cancelled:** Yes No N/A**Bridge No:** 34-0006**Component:** SAS OBG**Summary of Items Observed:**

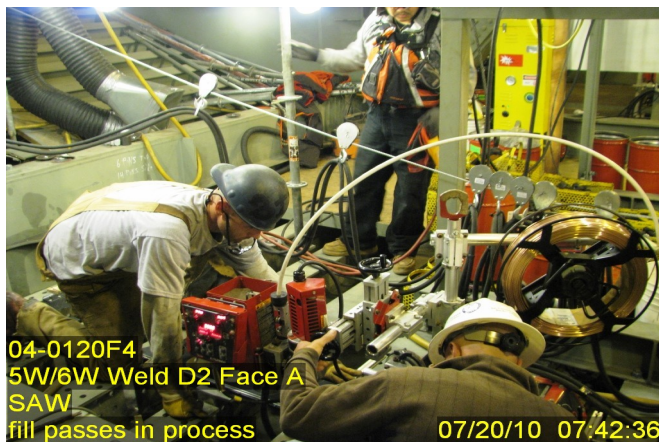
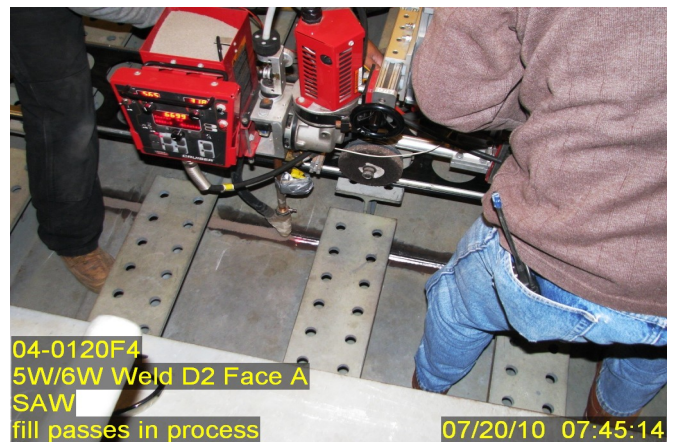
### 4). OBG Field Splice 5W/6W Weld ID: D1 & D2, Face A

The QAI periodically observed the in process welding of the OBG Field Splice 5W/6W weld ID: D1 & D2 Face A per the Submerged Arc Welding (SAW) process in the 1G (flat) position by approved AB/F SAW operators Dan Ieraci (ID 3232) and Kenneth Chappell (ID 3833). See photos below. The SE QC Inspector Jesse Cayabyab was present to monitor the progress and verify that the welding parameters were within the limits established by the approved welding Procedure Specification (WPS) identified as ABF-WPS-D1.5-4042B-1. Welding of the fill passes was in process for the remainder of the QA Inspectors shift and work at this location appeared to be in general compliance with contract documents.
